AN ELASTOMERIC COUPLING CASE HISTORY

Talmadge Ward

Duke Energy / VibRental LLC

Piedmont Annual Training – 2018 Lake Junaluska NC

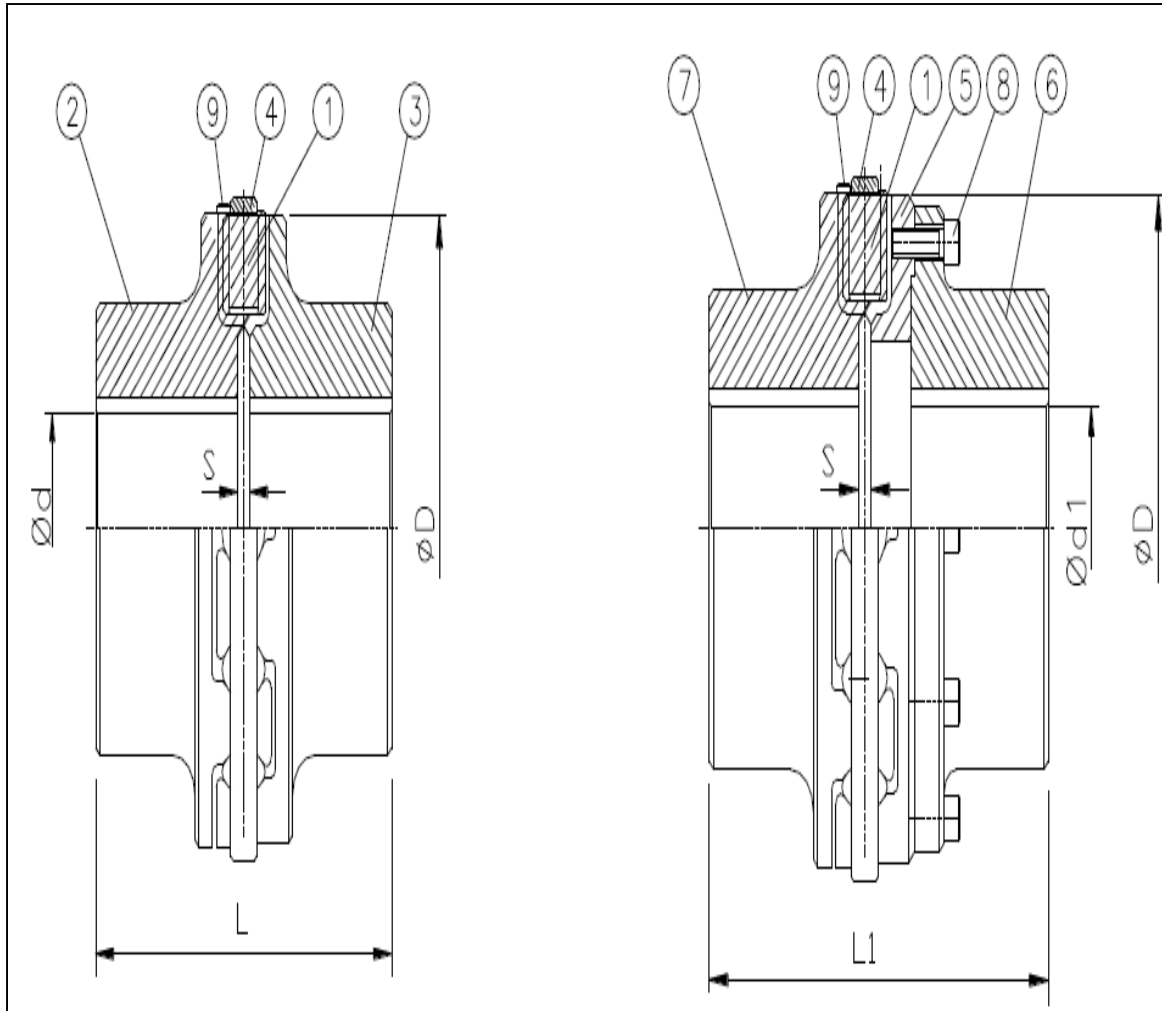
Coupling cross section view, Item #1 is the Elastomeric Element.

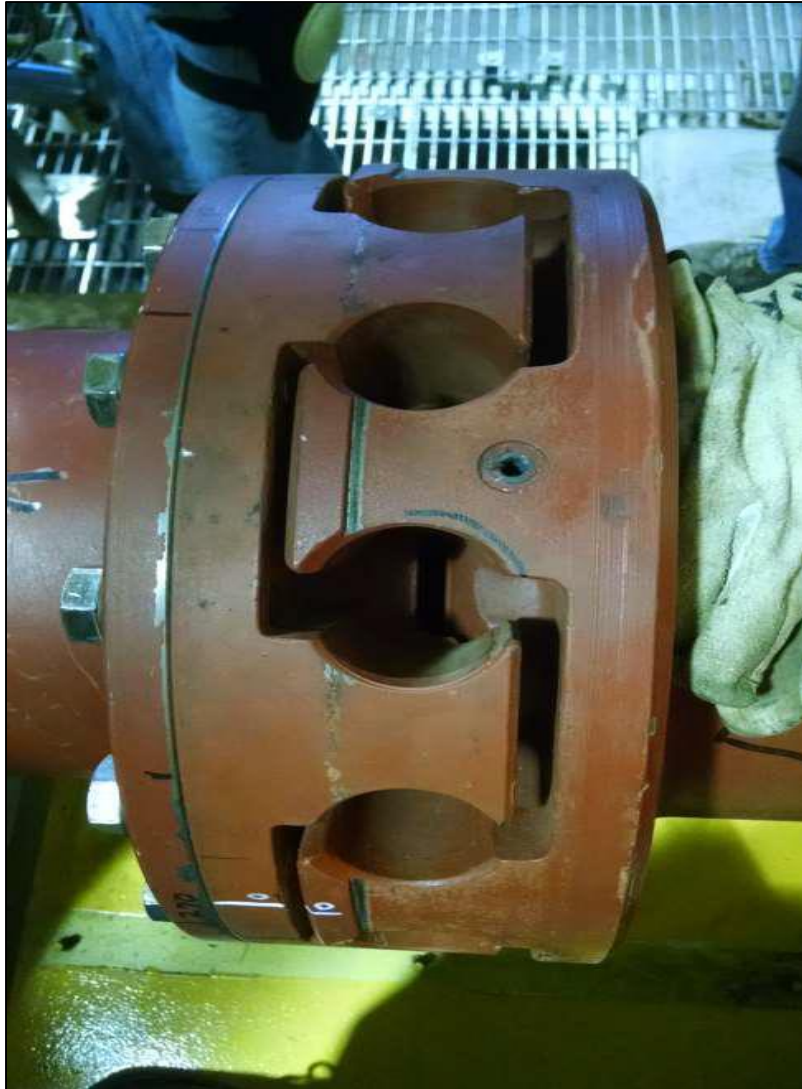
Coupling with
Elastomeric elements
removed. Note the
flange on the left side
for separating the
coupling halves

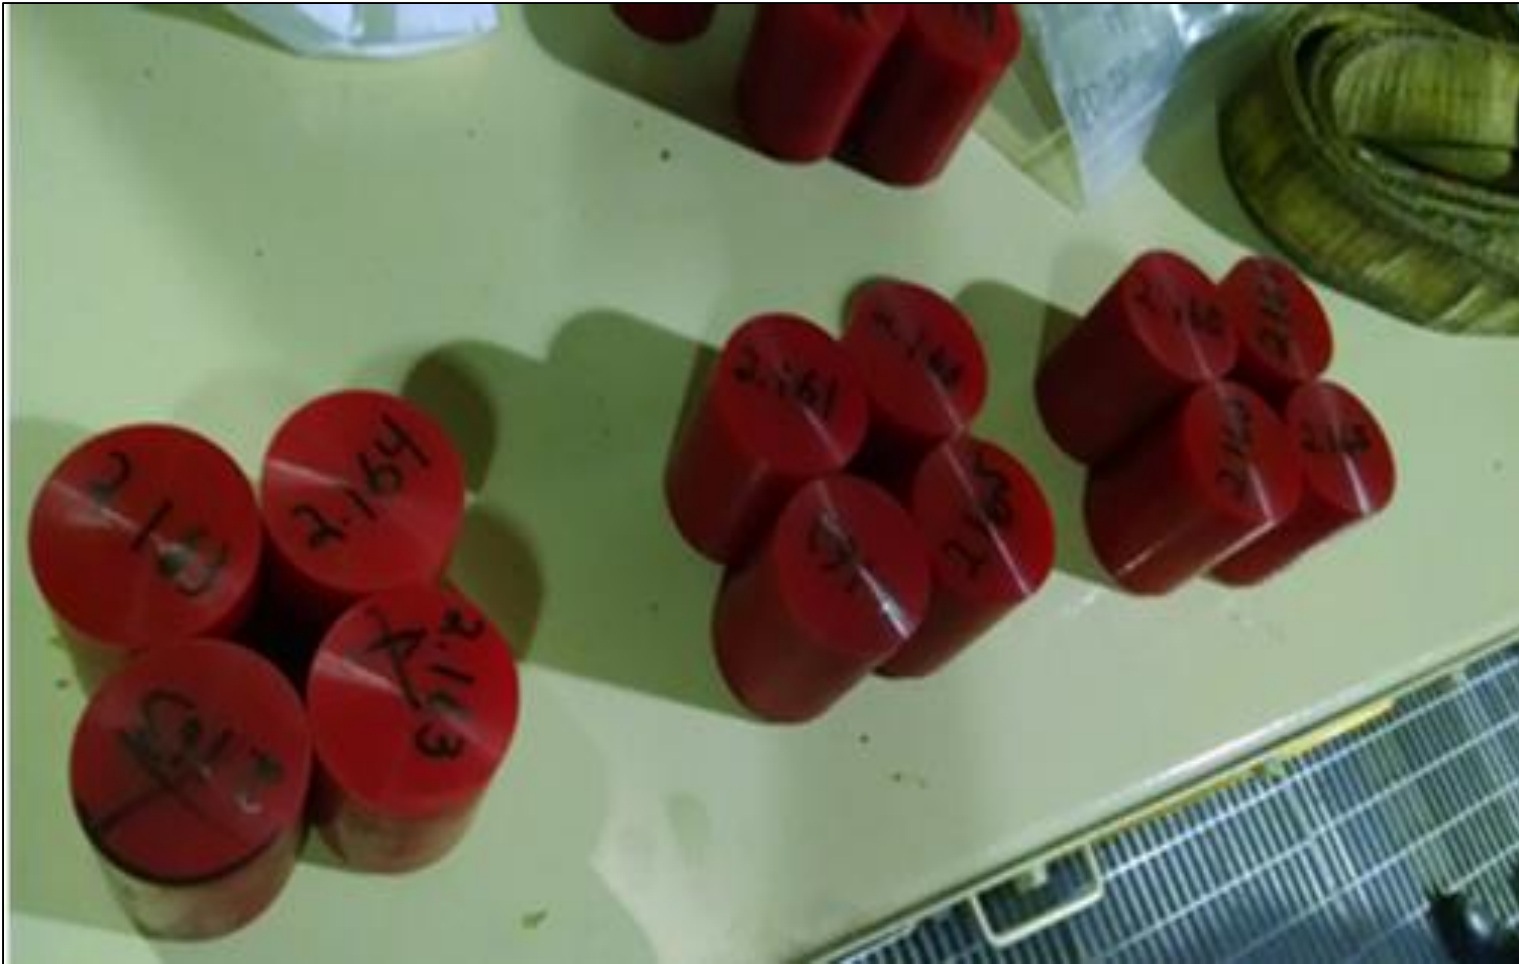
Coupling elastomeric elements removed from coupling and marked with their diameters measured.

Our attention turned to the elastomeric elements since all of the coupling checks found no issues. Basic inspection of the elements began and we documented the length and diameter of each element and compared this data to the vendor drawings. One major deviation came to light: the diameter of the elements were found significantly out of spec with a variation of 0.039” while the drawing limit was 0.011”. With little time or spare parts we decided to place the seven closest sized elements in the seven forward drive slots and the remaining seven elements were placed in the reverse drive slots.

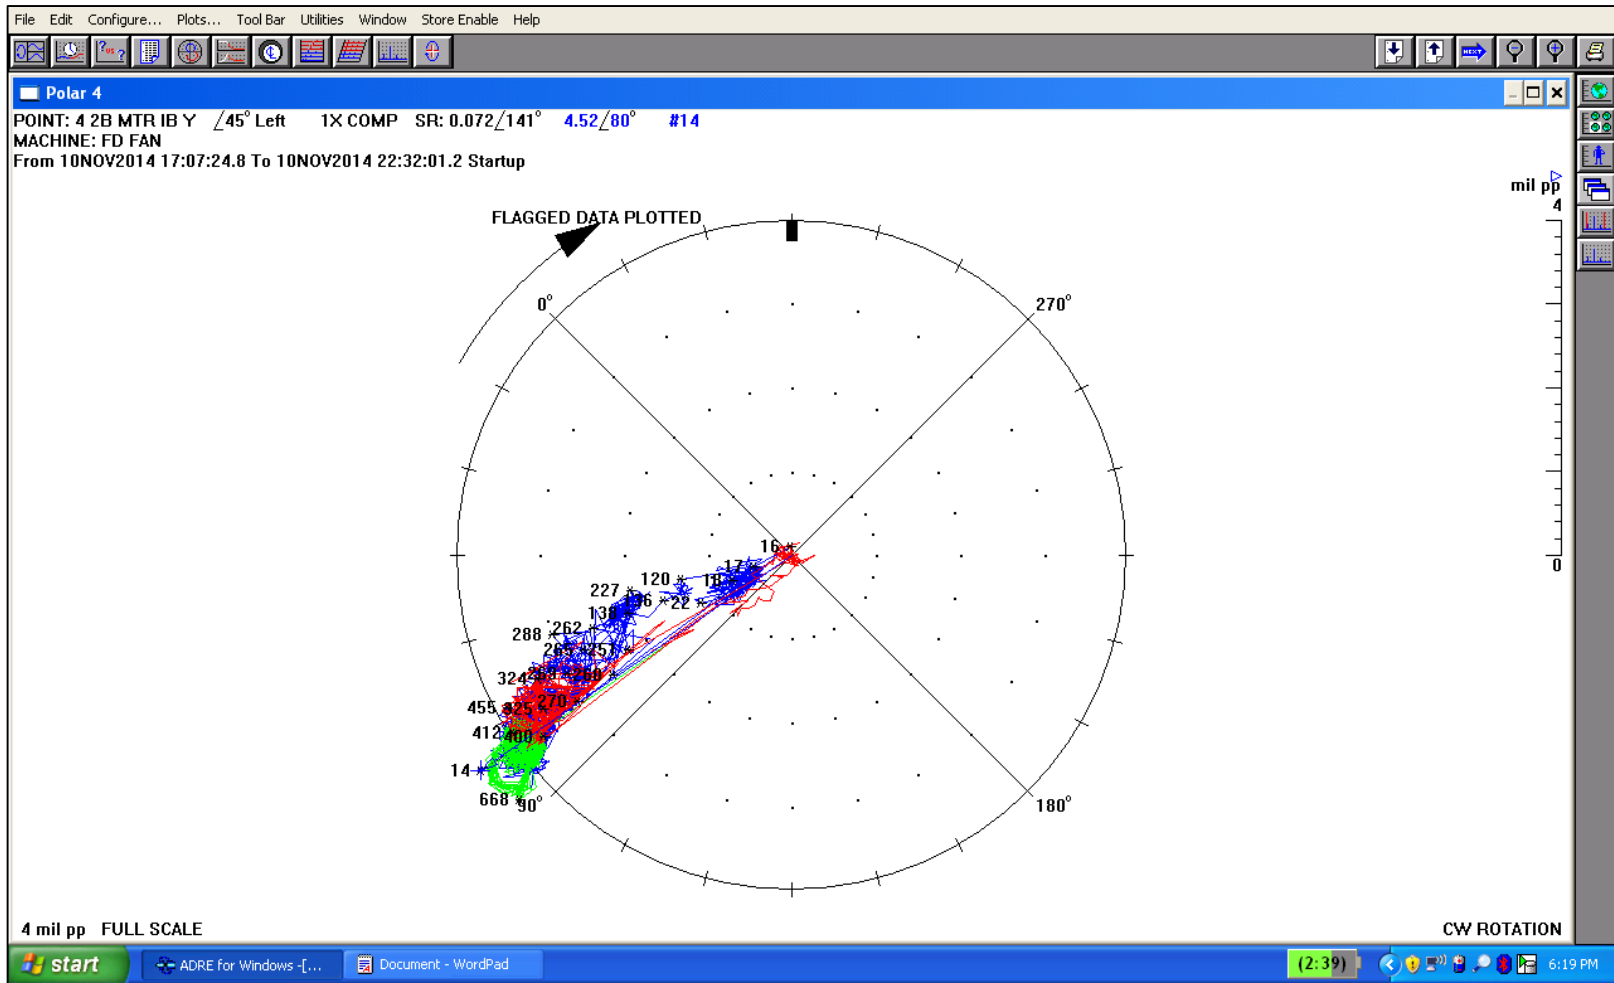
Initial Coupled Run - Motor IB Channel Y Shaft Relative

Note how motor IB-Y vibration levels increase at relatively constant phase (~ 80 deg) with increasing speed.

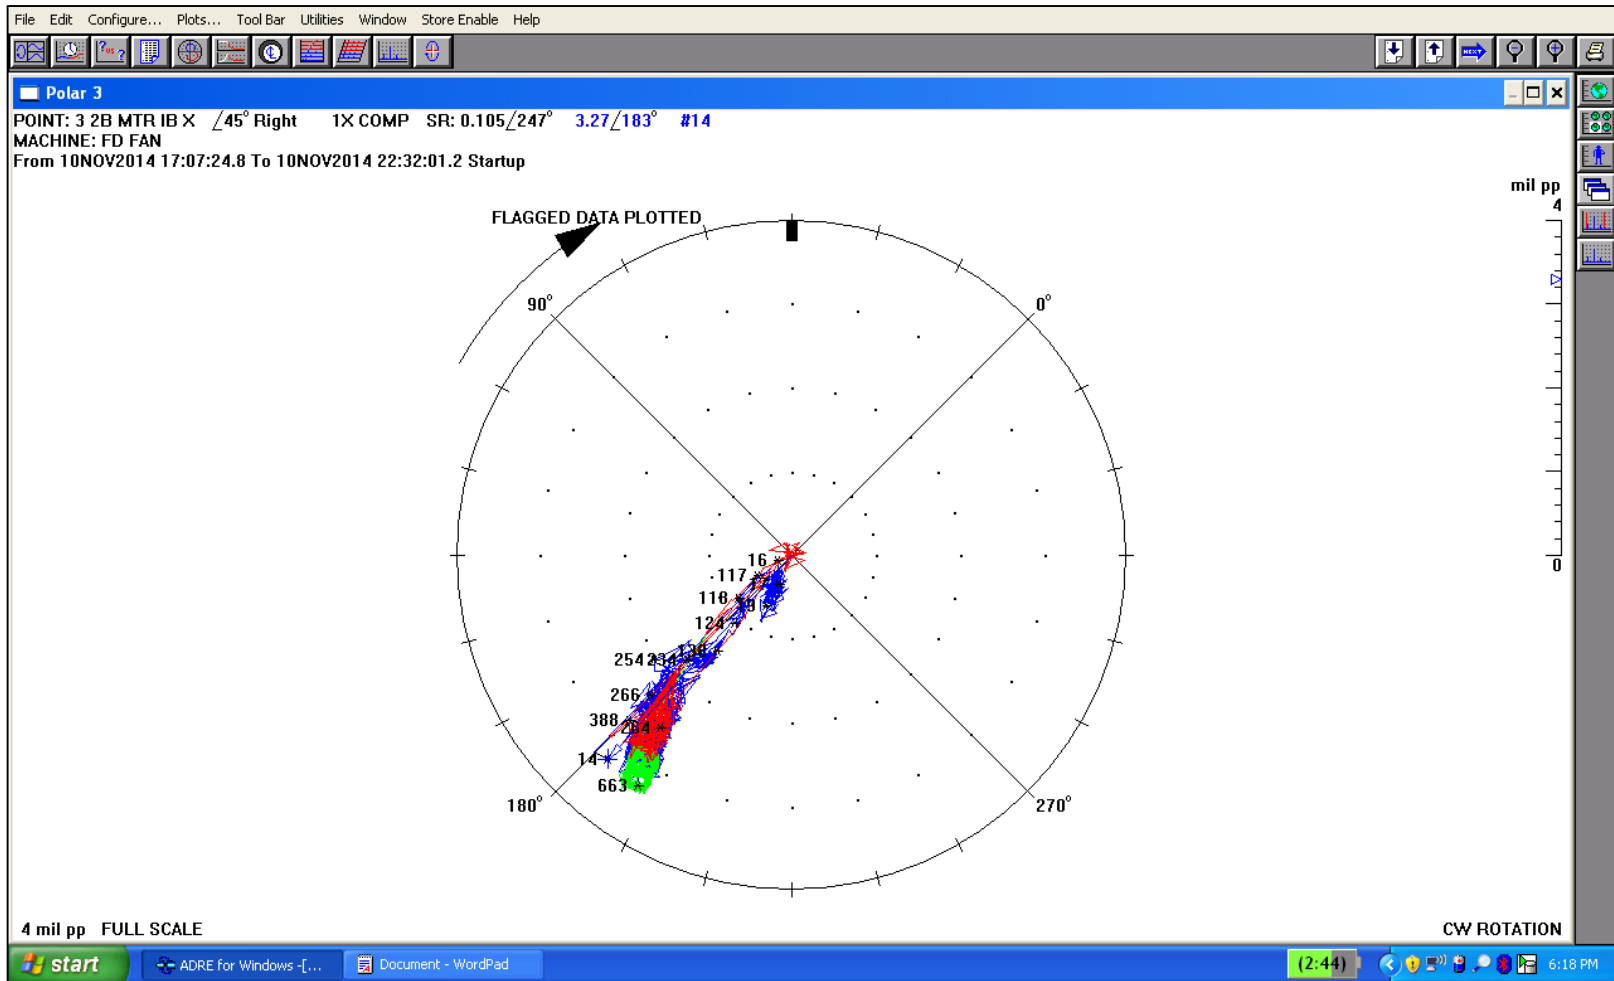
Initial Coupled Run - Motor IB Channel X Shaft Relative

Note how motor IB-X shaft vibration levels increase at relatively constant phase (~ 183 deg) with increasing speed.

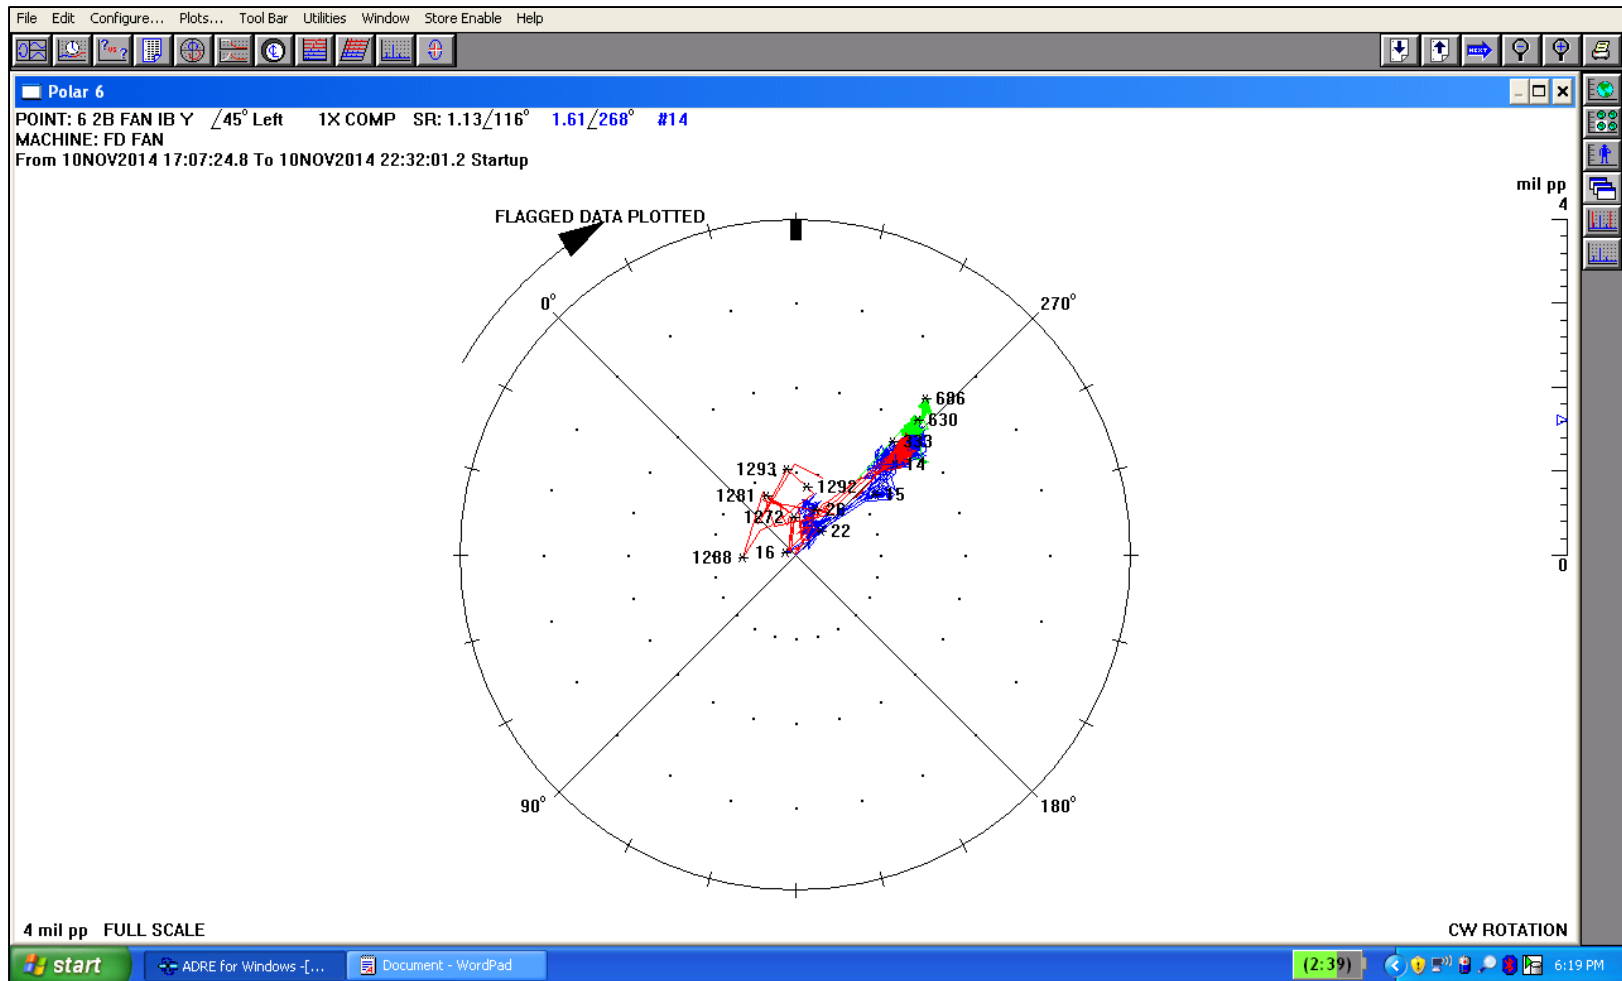
Initial Coupled Run - Fan IB Channel Y Shaft Relative

Note how fan IB-Y shaft vibration levels increase at relatively constant phase (~ 268 deg) with increasing speed. Note also how an ~ 180 deg phase difference exists between the motor & fan across the coupling (ie: compare 268 to 80 deg).

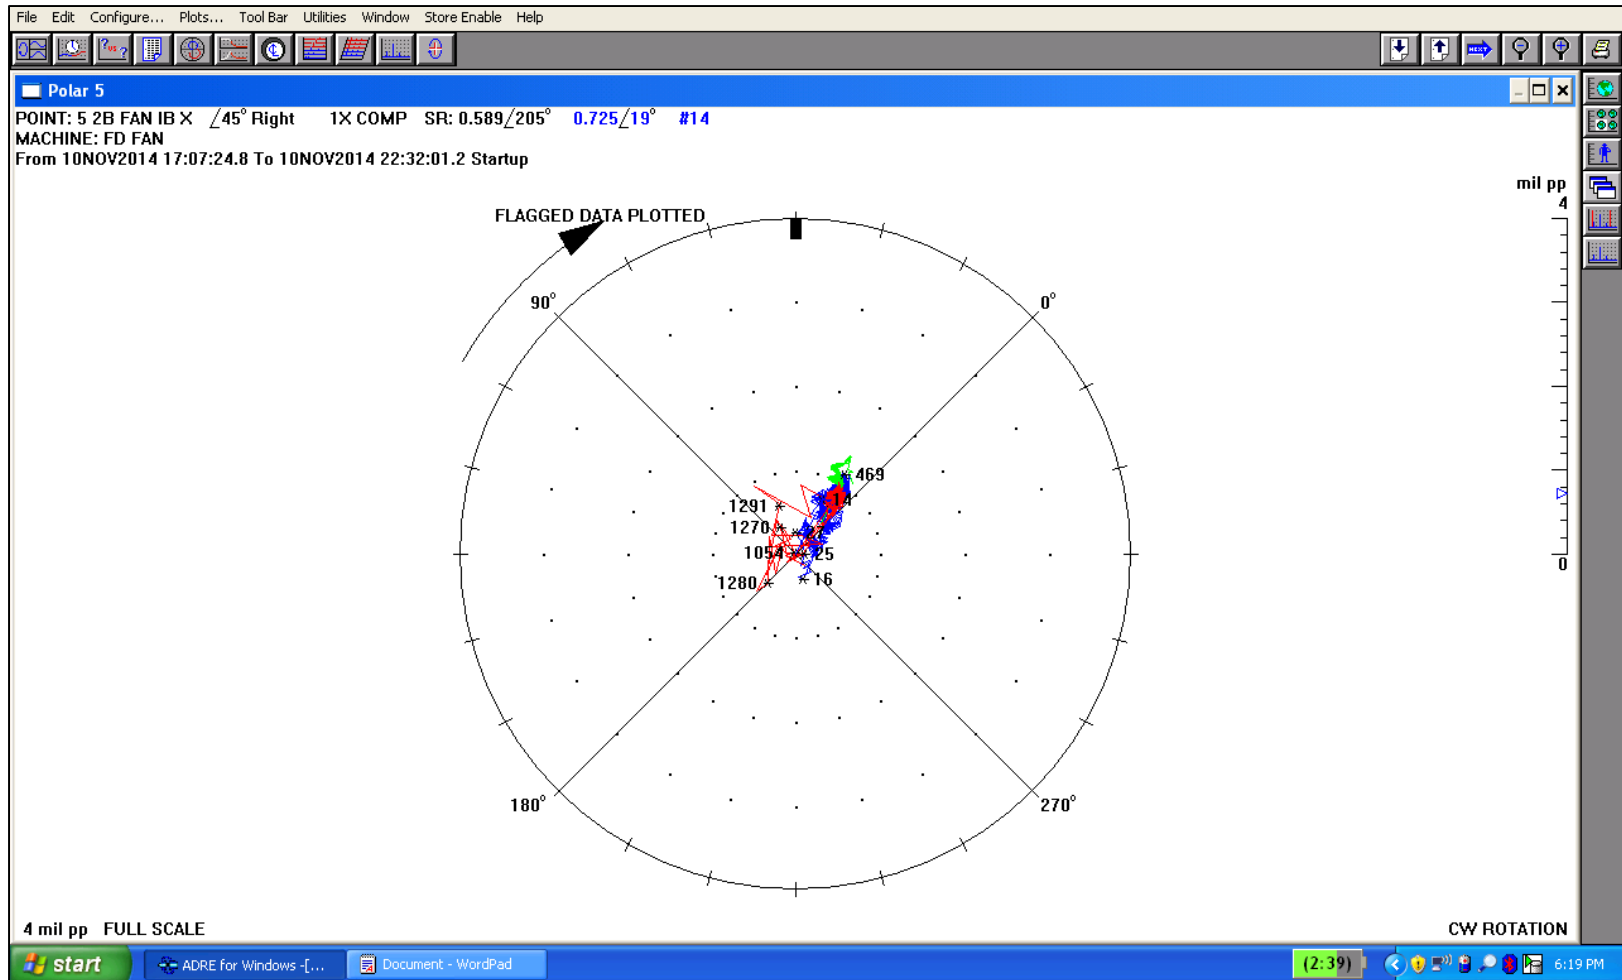
Initial Coupled Run - Fan IB Channel X Shaft Relative

Note how fan IB-X shaft vibration levels increase at relatively constant phase (~ 19 deg) with increasing speed. Note also how an ~ 180 deg phase difference exists between the motor & fan across the coupling (ie: compare 183 to 19 deg).

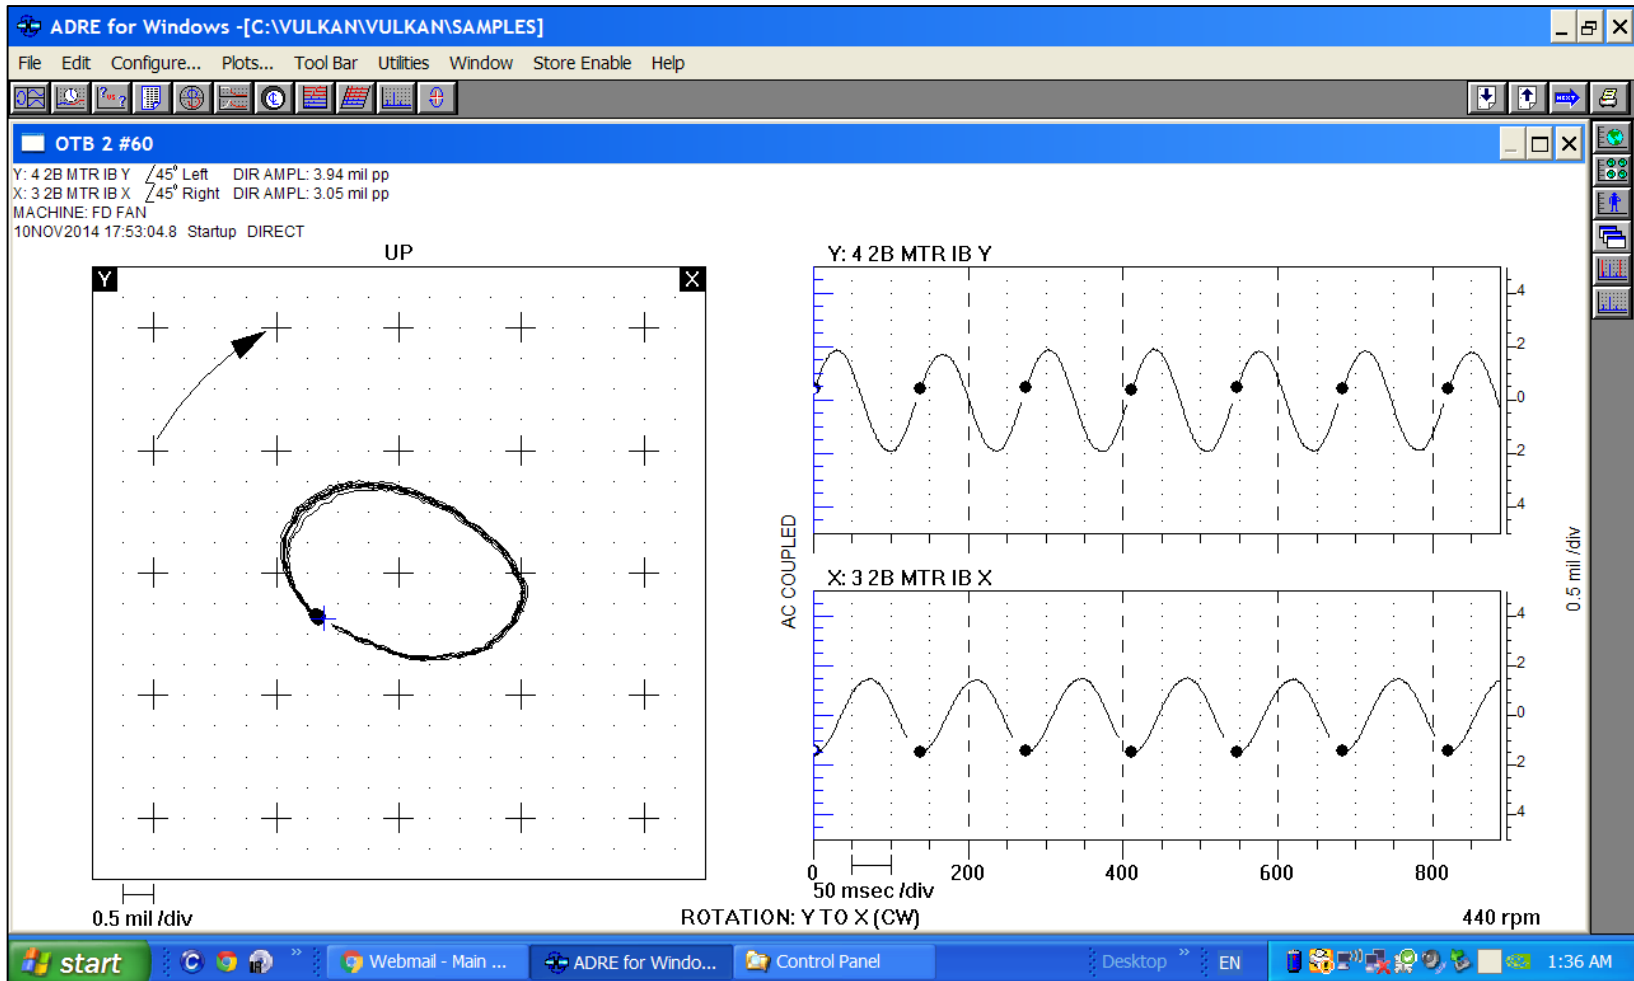
Initial Coupled Run - Motor Inboard Orbit & Time Waveforms
Note normal looking orbit (elliptical) and sinusoidal waveforms
Note dominant vibration at 1x rpm (440 cpm)

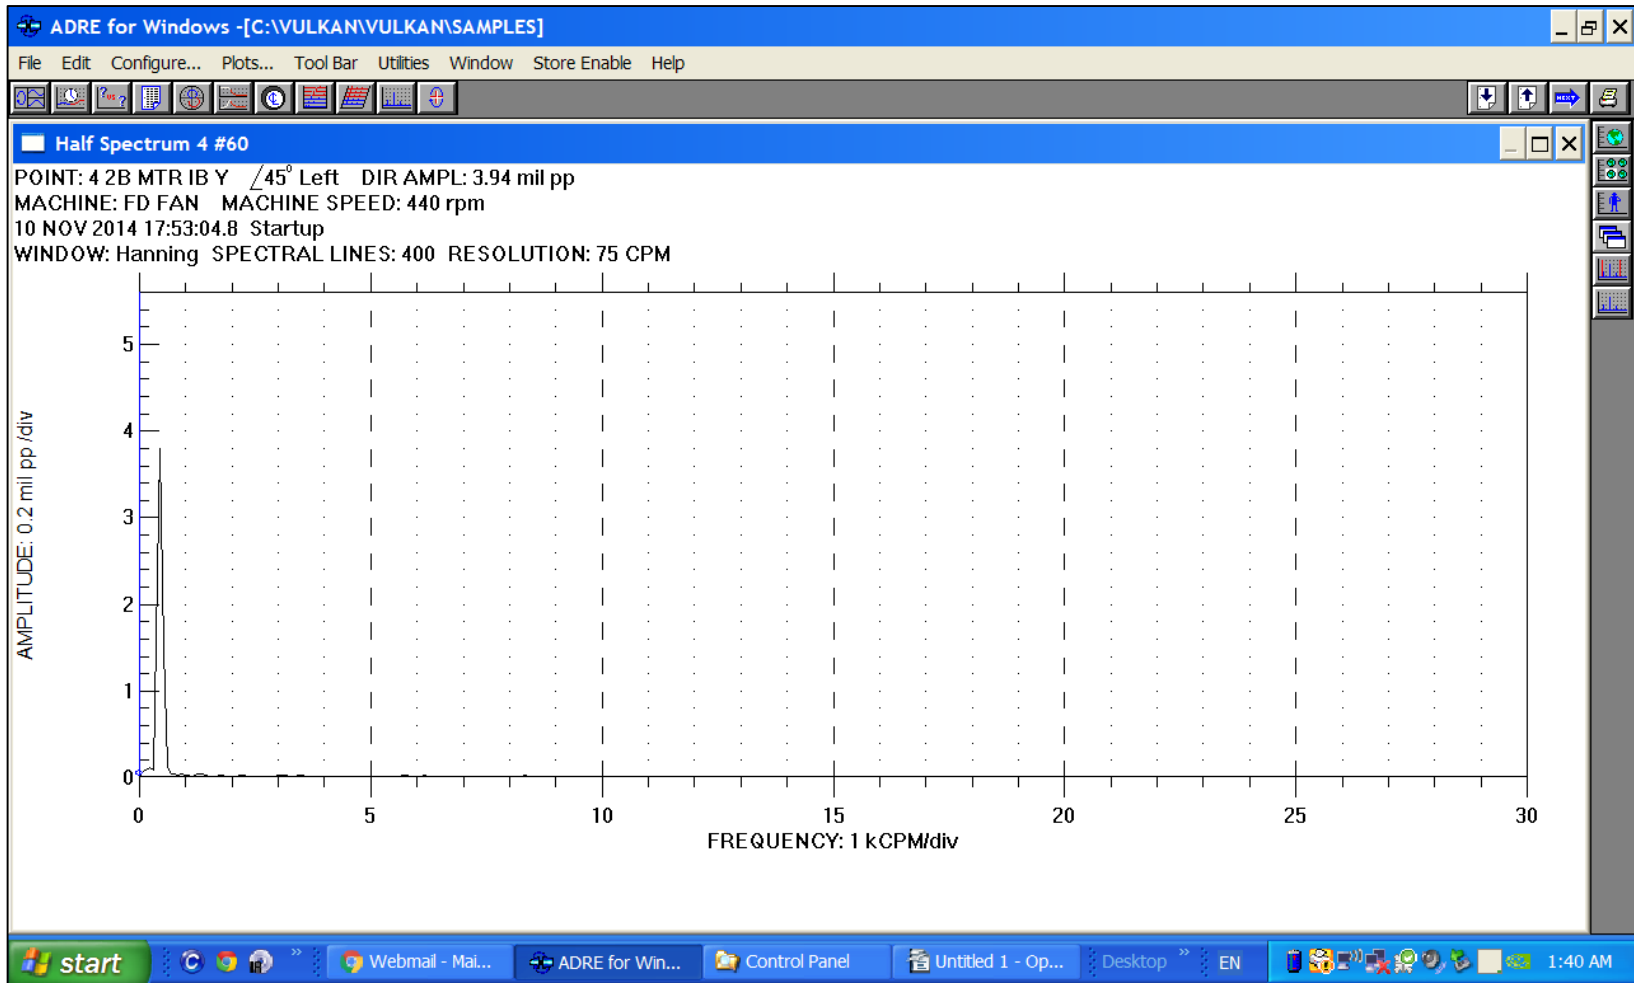
Initial Coupled Run - Motor Inboard Y Spectrum
Note dominant vibration at 1x rpm (440 cpm)

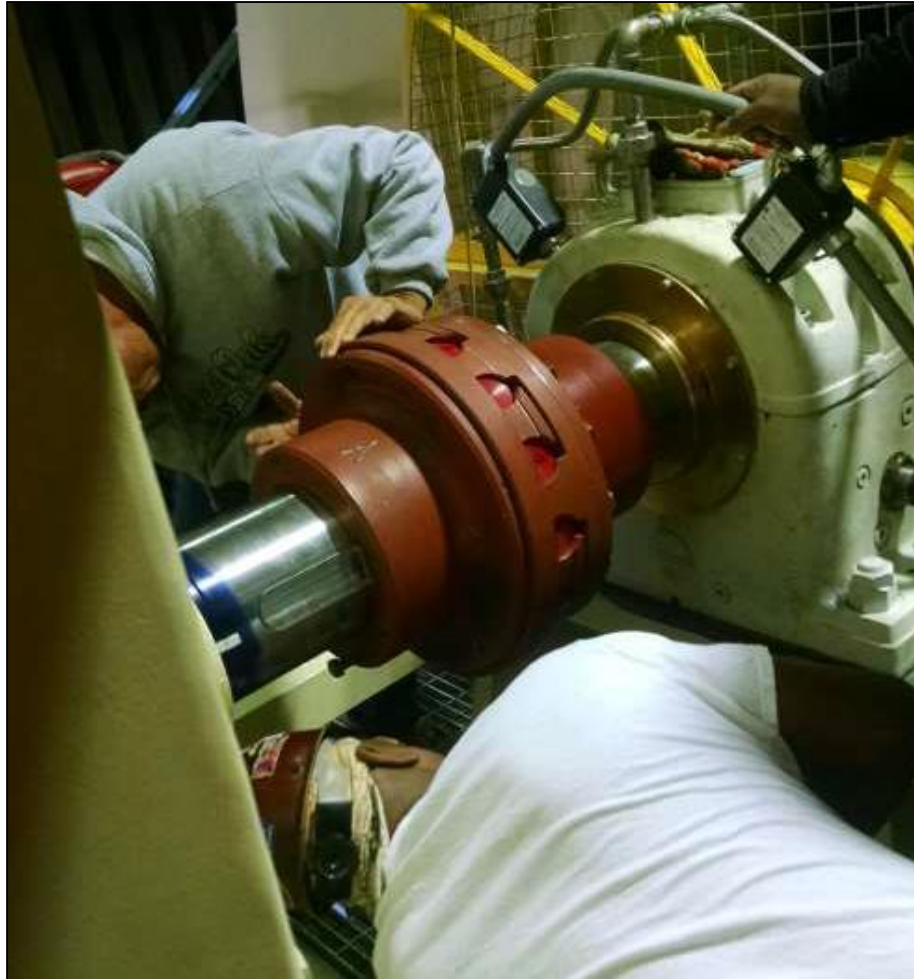
Coupling with elastomeric elements installed and the retaining ring not yet in place.

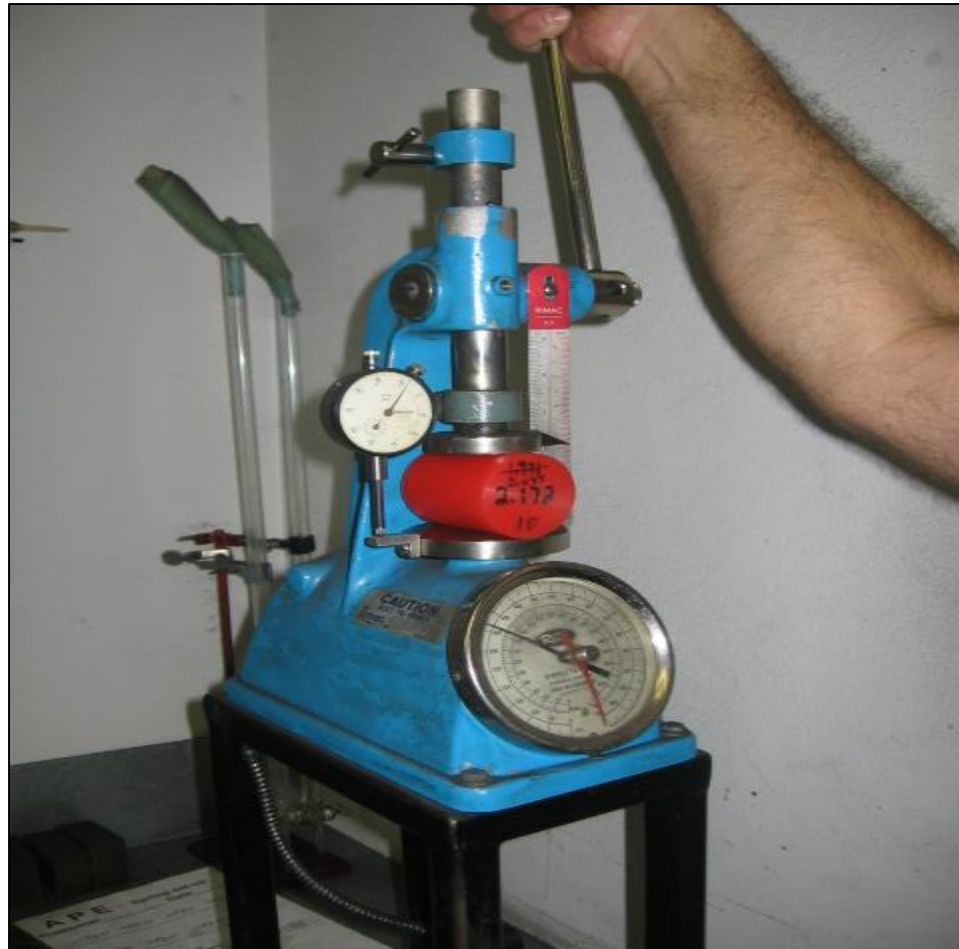
Automotive Valve Spring Tester with one element being tested. Note the large dial is the pressure reading and the small dial is the element diameter.

Since the Shore A durometer test only checks about 0.070" of depth below the surface I had to find a test method that would approximate the change of the elements when in service. I decided to use a standard automotive valve spring tester and apply the maximum force of 1,000 lbs. While this would be only about half of the service loading, it seemed a reasonable method. Valve spring testers are not typically used on everyday automotive engines but are reserved for racing engines where high rpm and high valve lift cause potentially damaging stresses. The process also required that we quickly documented the reading as urethane continues to compress over time with load and this could skew the results. Every element was tested, marked and cataloged. The loaded diametric range found was 2.022" to 2.064". A table of the data was made to more easily find the seven closest matching elements when under simulated load conditions.
